Hampden Suspension Bridge

- Long term structural health monitoring
Kangaroo Valley, NSW, Australia, 2005

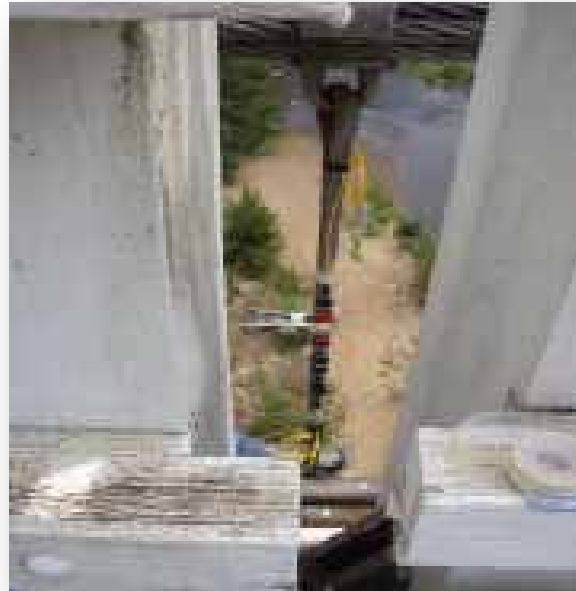
- § To this end, the RTA commissioned Monitor Optics Systems to develop and implement a long term, automated, structural health monitoring system for the bridge.
- § Monitor Optics Systems developed and installed a fiber optics based strain sensing system on the bridge. Surface mounted sensors measure strain in critical structural elements. The multiplexed sensors are routed to a control room at the bridge abutment.

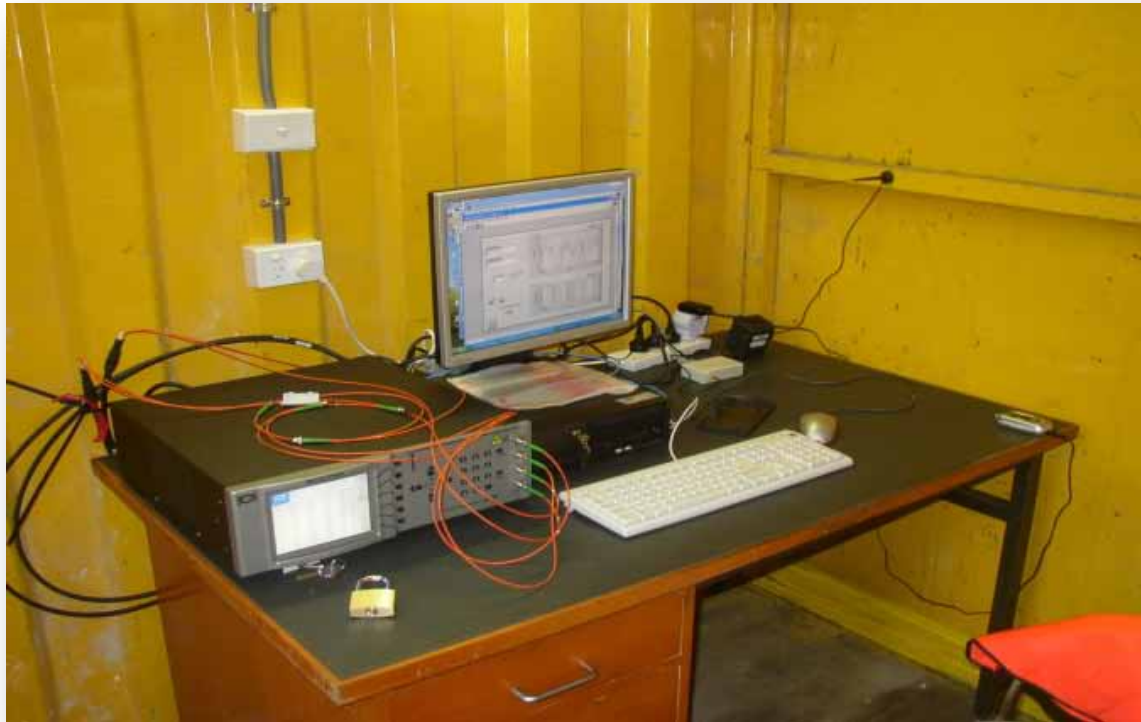
- § The Micron Optics si425-500 continuously interrogates the sensors. The acquired data is processed and transmitted automatically via GPRS.
- § The MOS Monitoring System provides a real-time measure of the structural condition of the bridge.
