Case Study – Mount Rushmore Rock Block Monitoring System

Keystone, South Dakota 2010

Mount Rushmore, Fiber Optic Strain Gage Install

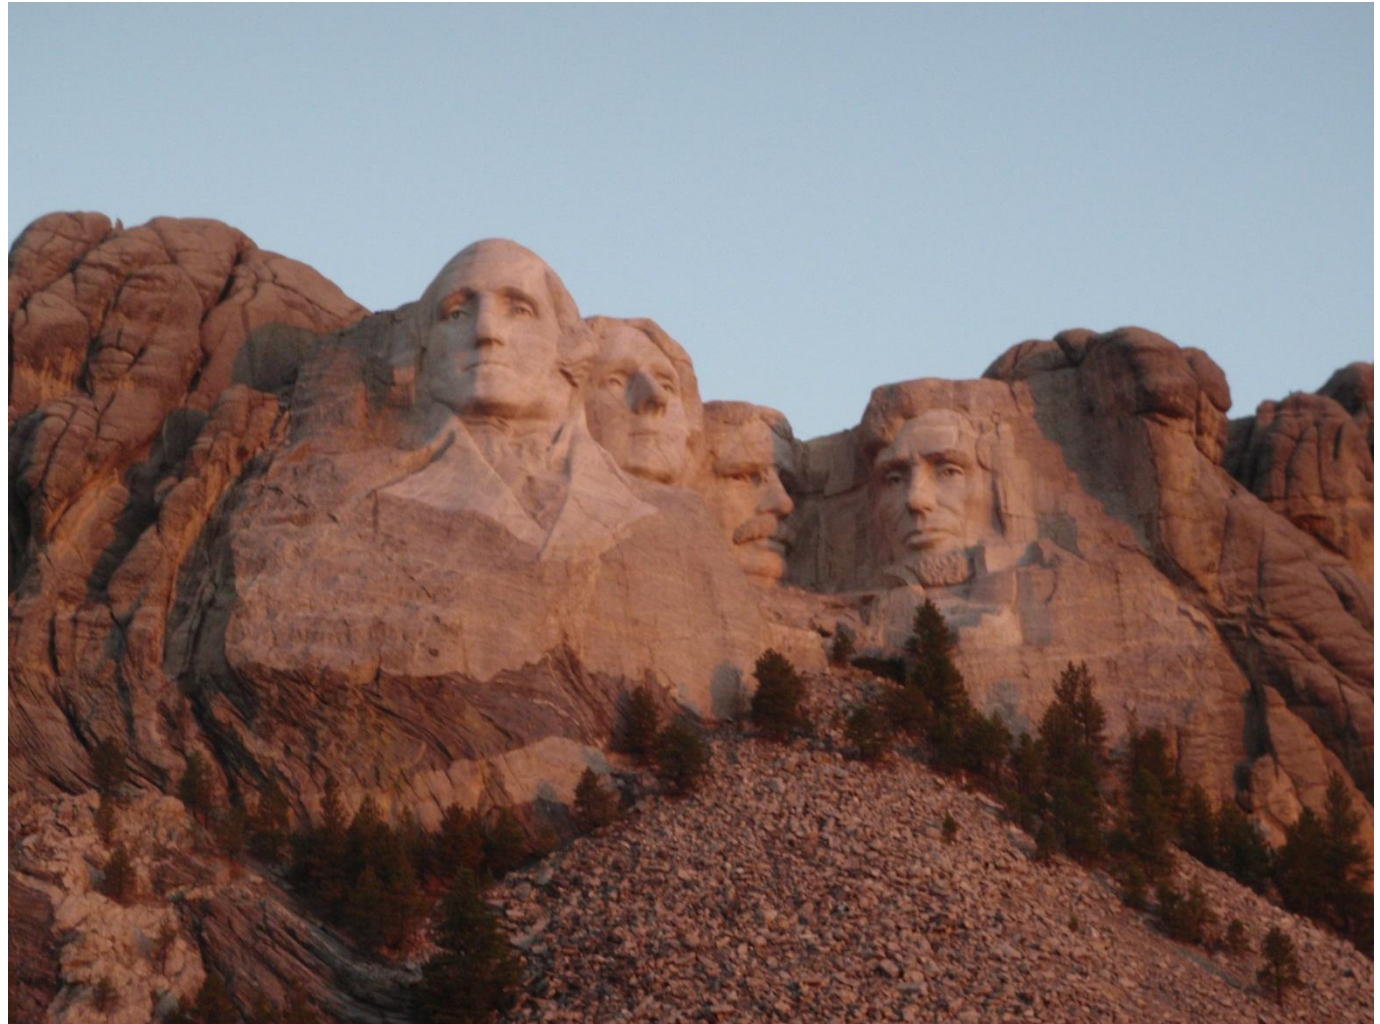
- A rock block is identified if one or more fractures combine to form a continuous trace
- Multiple Rock Blocks identified

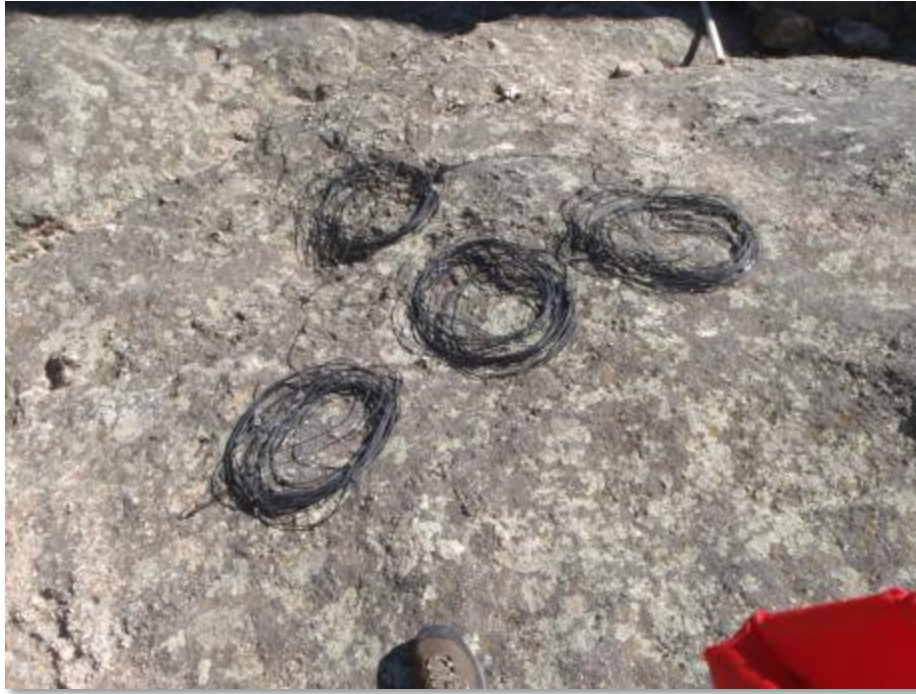
Installation of fiber cable runs for the four monitoring locations.

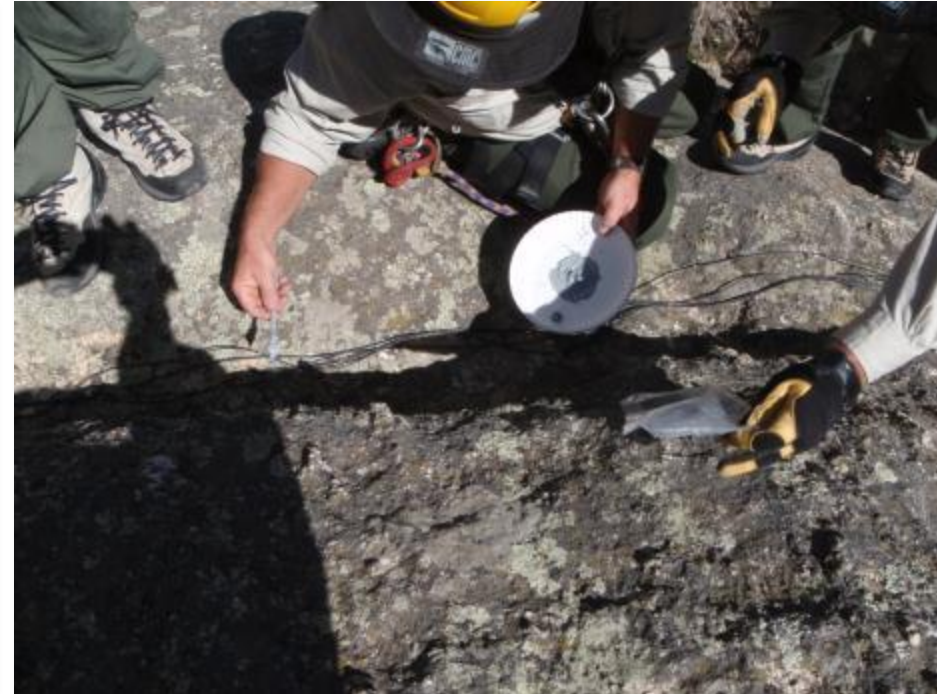
Securing the tie down clips to the rock with epoxy for securing the fiber cable runs.

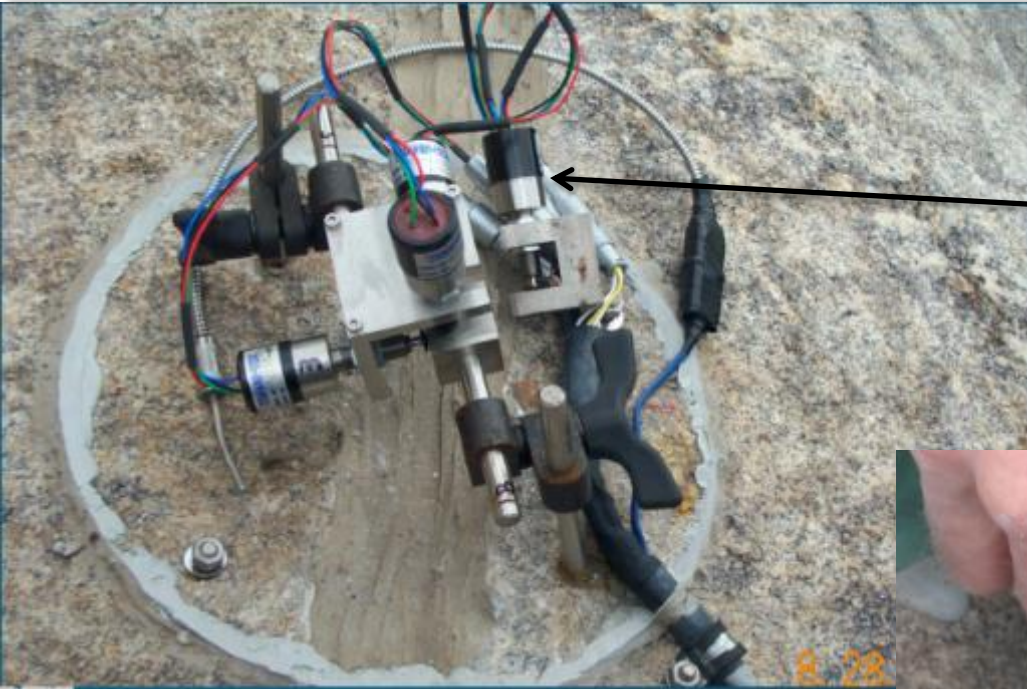
Previous monitoring system utilizing LVDT's

New monitoring system utilizing os3110 strain gages mounted on either side of the small cantilever beam. Temperature compensation is realized thru an active dummy gage configuration.

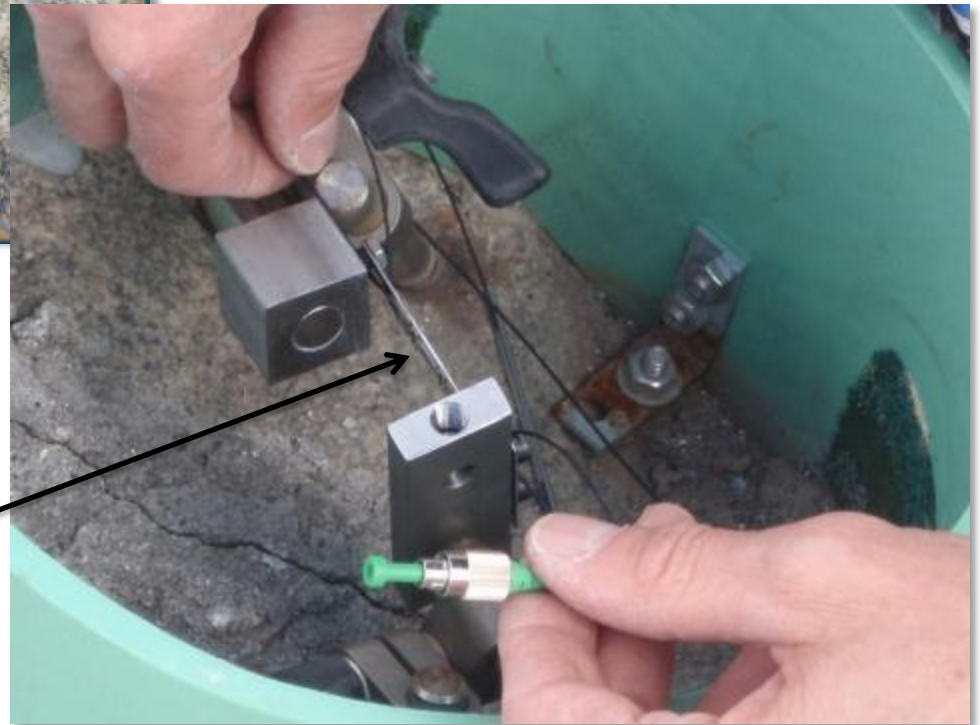
os3110 Weldable Strain Gage

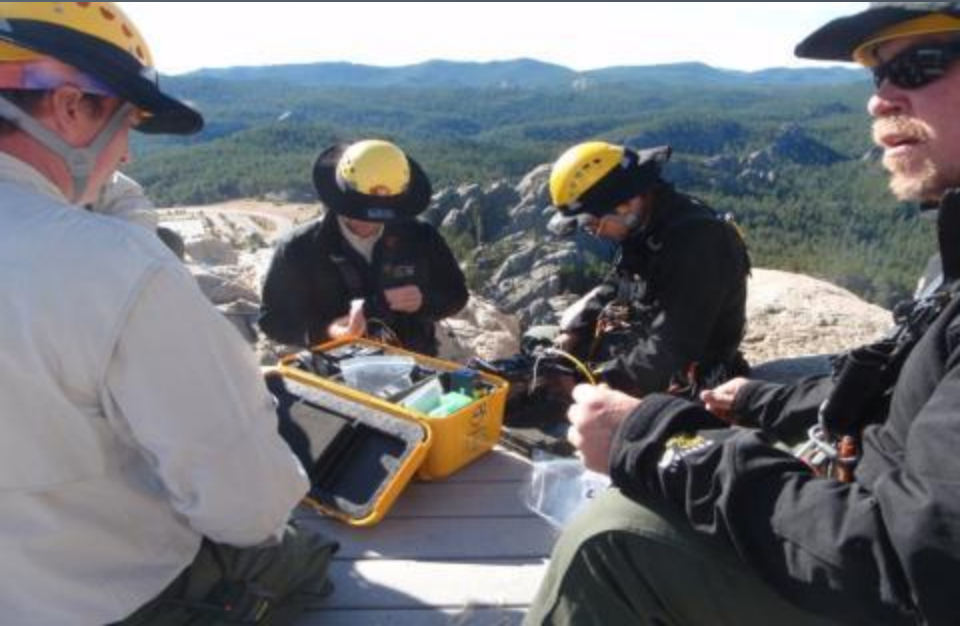
Rope Access Team performing optical fiber splicing operations on top of Mount Rushmore. Cable splicing is a standard process for optical fiber based systems like this optical sensing application.

- Installation a success, fiber splicing performed on top of the monument. Gage orientation performed while roped off and hanging in place in front of monitoring stations.
- System design allows for damaged gages or cable to be replaced with minimal intervention.
- Absolute temperature measurements made at each location with os4310. Temperature compensation for strain measurements realized thru active dummy gage configuration on a cantilever beam.
- Fiber optic system's immunity to voltage gradients due to lightning or Electro Static Discharge allowed abandoned monitoring station reactivation.
- Hundreds of pounds of copper removed. Four, three millimeter fiber cable runs eliminated the need for copper cable harnesses. Aesthetics of the monument improved for the public.
