Case Study – Roadways

- Phase 1 - Hume Highway,
New South Wales
Australia 2007

Road Pavement Monitoring

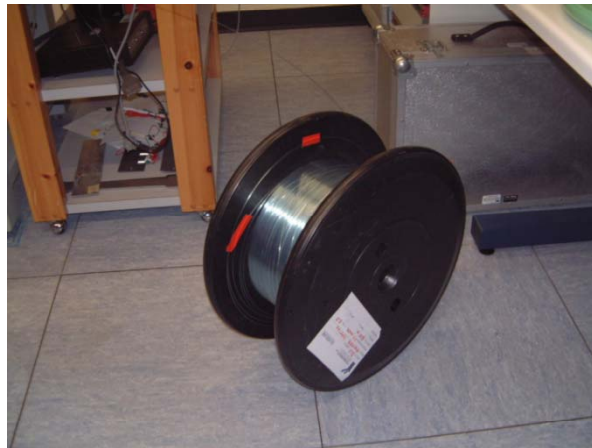
1 km long, 1 mm diameter cable

- Road pavements have suffered impacts in the form of structural distress resulting from mine subsidence movements and mining-induced ground strains. Much of the ground strain is transferred to the pavement through the ground movement and interface friction between structural layers.
- Monitor Optics Systems has developed a method of embedding one or more optical fibers into a Glass Fiber Reinforced Composite (GFRC) cable.
- These cables can be up to kilometers in length, are readily deployed in the field and provide a very high level of protection to the optical fiber while maintaining its sensitivity to changes in temperature and strain.

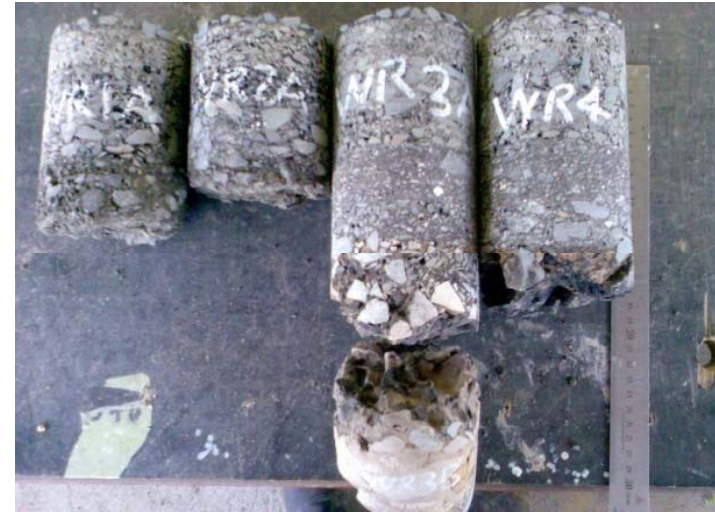
- The monitored road was subjected to mine subsidence movements during the mining of Longwall 302 at Appin Colliery, which is located in the Southern Coalfield of New South Wales. The site is approximately 90 kilometers southwest of Sydney.
- Wilton Road is a two-lane road with an asphaltic concrete (AC) pavement at this location. Four core samples were taken and these indicated a 14 mm chip seal above multiple layers of AC10 and AC14 of depths between 90 and 180 mm, with 100 mm thick sub-base of unbound or bitumen stabilized crushed rock, and a select sub-grade layer of crushed sandstone.
- Optical fiber sensors were placed in the asphalt layer approximately 5 cm below the surface along a 90 meter long section of pavement on this road.

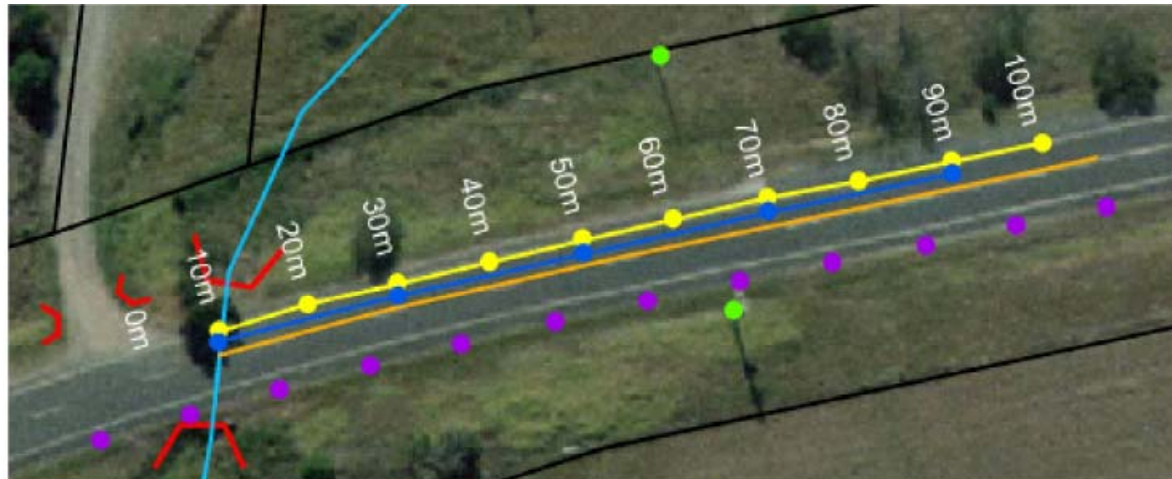
Location of Installation

- The cables were fixed to the pavement with an epoxy resin called Megapoxy CT5.
 - The selected epoxy is used by the RTA for other road installations and in the airline industry for runway lighting.
 - The epoxy is resistant to physical damage and is colored black.
 - The epoxy was poured into the groove and trowelled smooth.
- The sensor cables were placed directly above Longwall 302 at the locations shown in the picture below. The FBG strain sensors are shown as yellow dots, the FBG temperature sensors are shown as blue dots and the ground survey pegs are shown as purple dots.

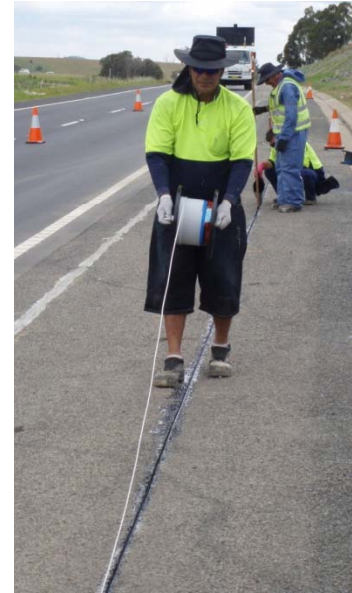
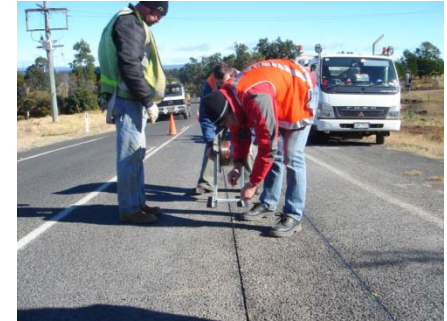
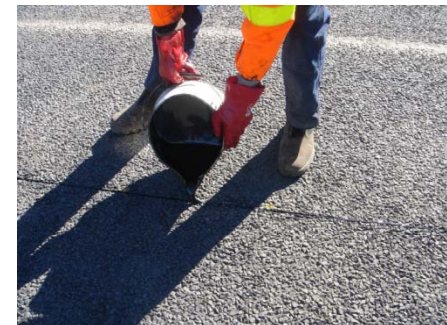
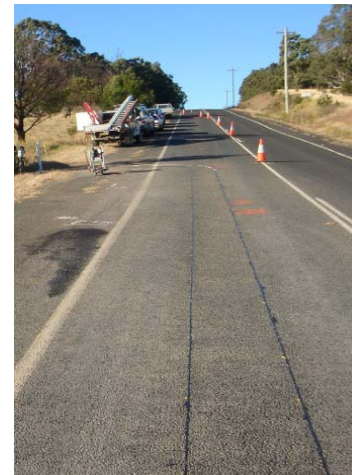
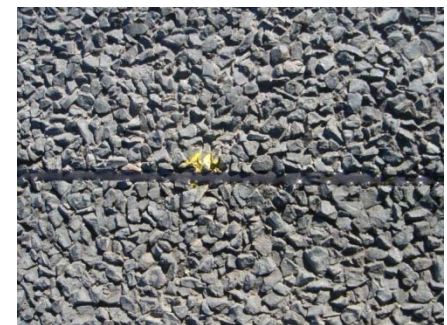
- The sensors were embedded into the pavement in July 2007.
 - A groove of approximately 8 mm wide and 20 mm deep was saw cut into the pavement along the center line of the eastbound lane.
- The following cables were manually placed into the groove via spool reels:
 - One Distributed Strain Sensor Cable of 1mm diameter containing 10 FBGs at 10 m spacing.
 - One Distributed Temperature Sensor Cable of 5mm diameter containing 5 FBG temperature sensors at 20 m spacing.
- The epoxy resin was poured around the two 1 mm diameter cables in one application.

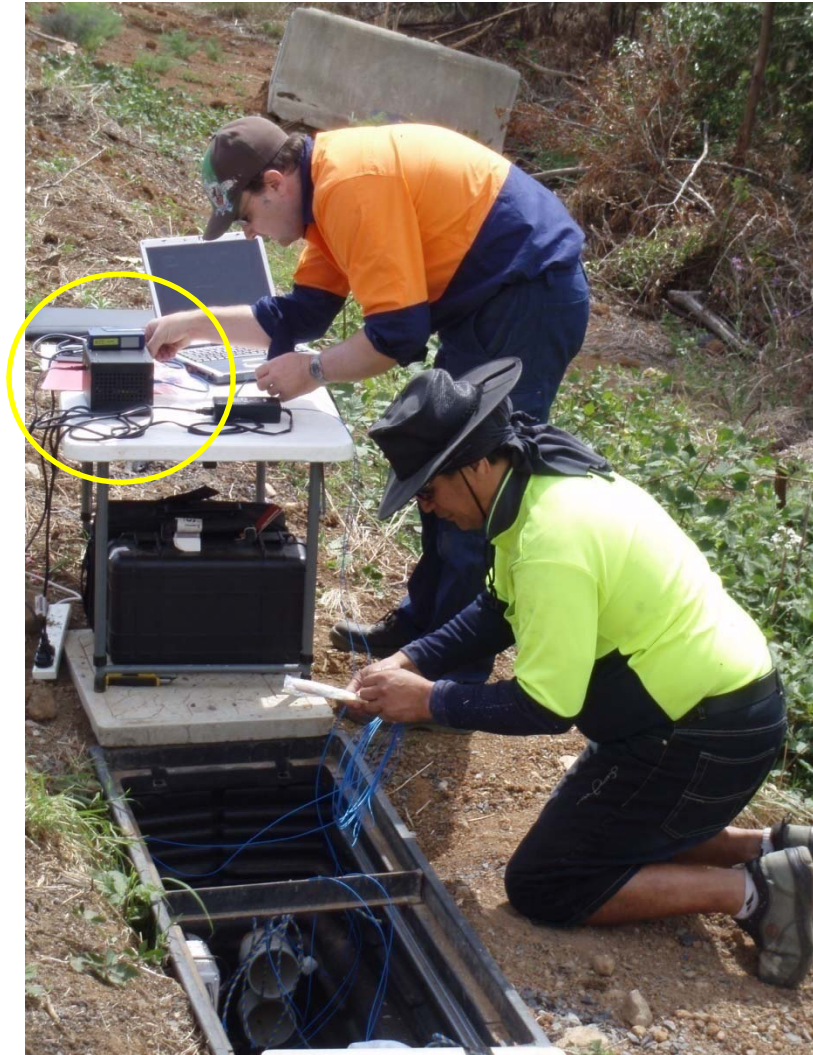
- Temperatures are accurately measured at strain sensing locations for determining thermally induced strains.
 - The temperature sensors were placed within 300 mm of the strain sensors.
- The sensor cables were terminated in a buried pit at each end, located just beyond the pavement shoulder.
 - The cables at one pit were connected to signal carrying cables that were connected to an interrogator housed in a secure container.
 - The cables at the second pit were coiled up and prepared for future connection should some or all of the cables experience a break during mining.
- The installation of the optical fiber cables was very successful and all FBG sensors were operational.
- A Micron Optics sm125 (see photo) instrument was used in the field for its proven reliability and accuracy.

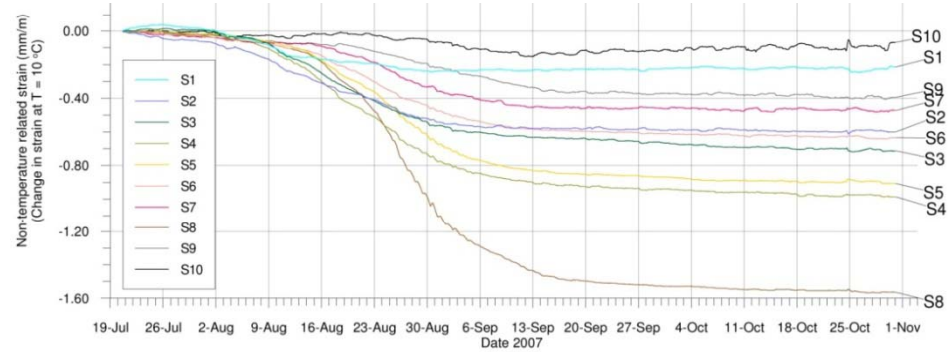
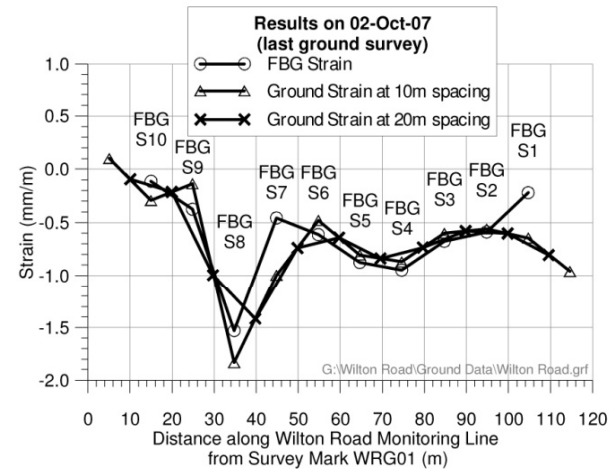
- Computer programs were used to automate the data collection and analysis during the mining period.
- Mining-induced strains were calculated every 15 minutes and the results are shown in the graph.
- Calculations were made over 20 meter bay lengths and correlation between ground strain and FBG strain is good for either bay length.
- The good correlation indicates that full transfer of ground to pavement strain occurs with little or no redistribution of strain along the pavement.

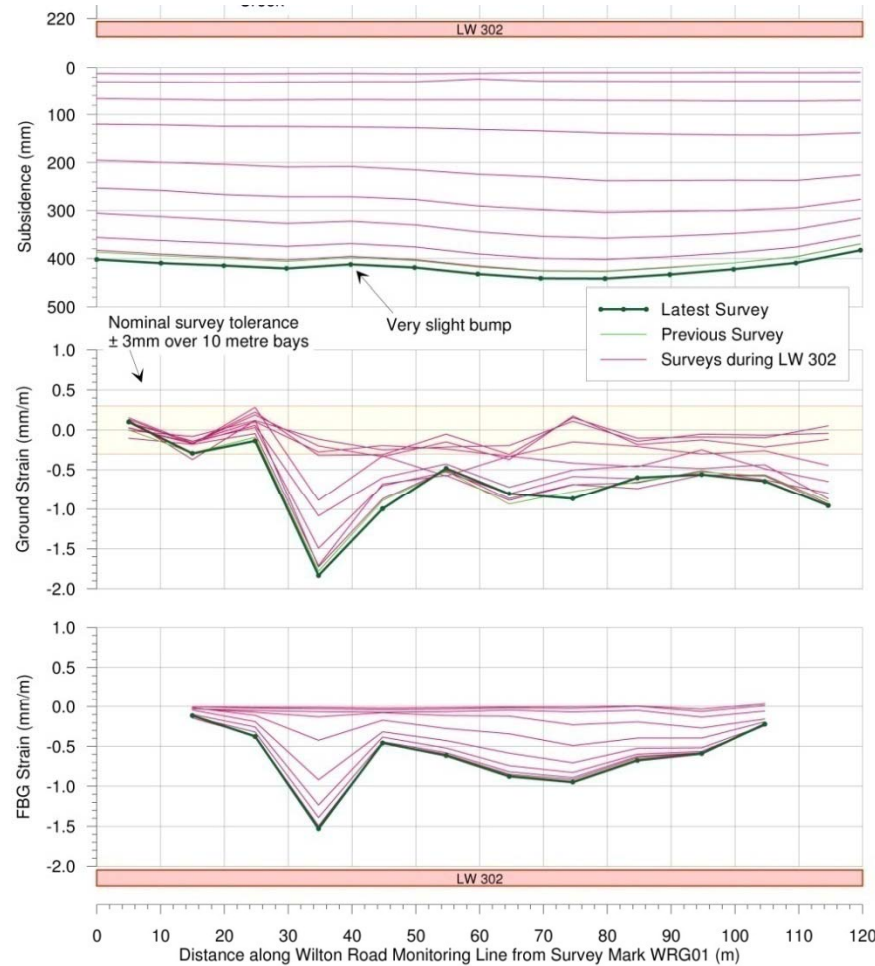
- A comparison between subsidence, ground strain and calculated mining strains from the FBG results (FBG strain) along Wilton Road.

- The results indicated a very good correlation between ground and pavement strain at all times.
 - Comprehensive pavement risk management requires that the FBG-based monitoring is conducted in conjunction with other monitoring such as ground survey and visual monitoring.
