The Application of FBG Sensing in Monitoring Hulanhe Bridge in Heilong Jiang Province

Dr. Zhi Zhou, et.al., School of Civil Engineering
Harbin Institute of Technology, Harbin, China

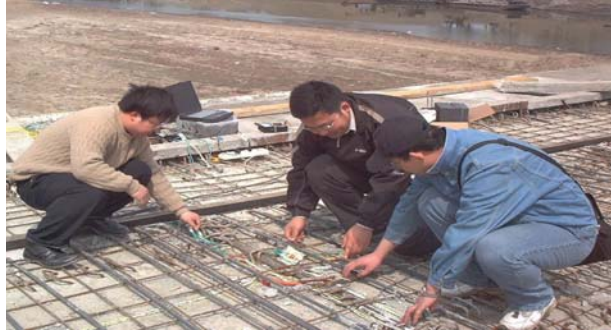
Fig.2. FBG sensor installation on bridge surface.

During the construction phase from May to October, 2001, the HIT group instrumented 15 FBG sensors to the 42-meter suspended section to monitor stress and structural health during construction and after bridge commission under live traffic load. After determining the representative stress locations, we chose to install 5 FBG strain sensors on the rebar in the 2nd and 5th bridge segments, as illustrated in Fig.1. During the bridge surfacing phase, we installed 7 FBG strain sensors and 3 FBG temperature sensors on the rebar as illustrated in Fig.2. For comparison, we also installed standard electrical strain gauges at corresponding locations.

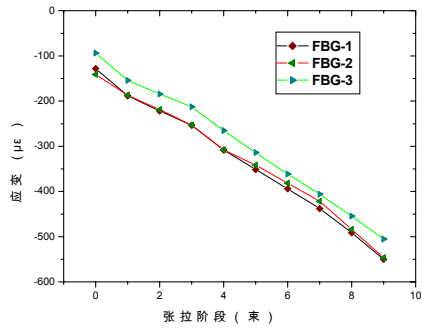
Fig.3. FBG strain versus bridge stress parameter

The concrete was allowed to cure for 10 days. Several sensors were destroyed during construction. The remaining FBG sensors all performed well. Only one surviving electrical strain gauge had stable measurement readout. We compared the data from the FBG and electrical strain gauges by subjecting the bridge to varying stress conditions. The resulting measurements for sensor strain ($\mu\epsilon$) versus bridge stress parameter plotted in Figs.3 and 4 demonstrate reliable FBG sensor measurements that correspond well with the forcing parameter; on the other hand, the electrical strain does not correlate as well.

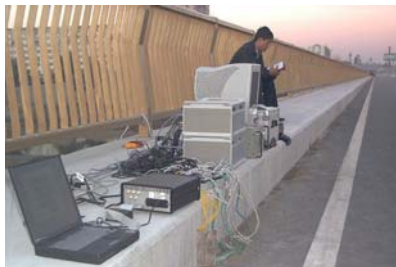
Fig.5. Measurement service on Hulanhe bridge (left), and FBG sensor display on Micron Optics FBG sensor interrogation system (right).

In May 2002 the bridge was commission for live traffic. The FBG sensors continue to show reliable measurement, while only 1 electrical strain gauge on the bridge surface survived. Samples of the FBG strain and temperature measurements during bridge operation are shown in Figs. 5 and 6.
