Establishment the Bridge Scour Safety Monitoring System by Using Fiber Bragg Grating Sensors

Yung Bin Lin¹, Kuo Chun Chang²

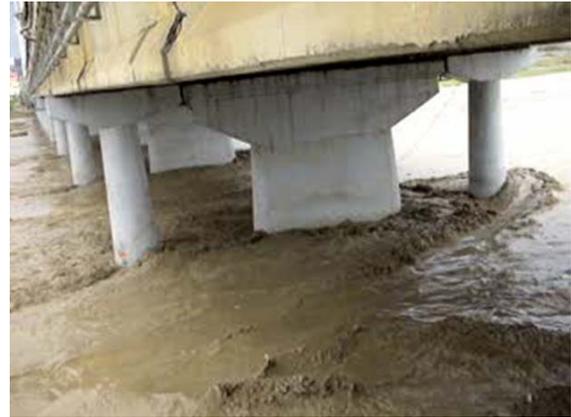
Figure 2 Water condition in the Aery flood

Figure 1 shows the installation location of the FBG monitoring system in the Dadu Bridge. The distance between each sensor is one meter. The top sensor was installed one meter above the riverbed. The water flow condition in the Aery flood event is presented in Figure 2. The measured data of the scouring processes from FBG sensors are shown in the Figure 3. As shown in the Figure 7, there are two signals emerging to show the fluctuations.

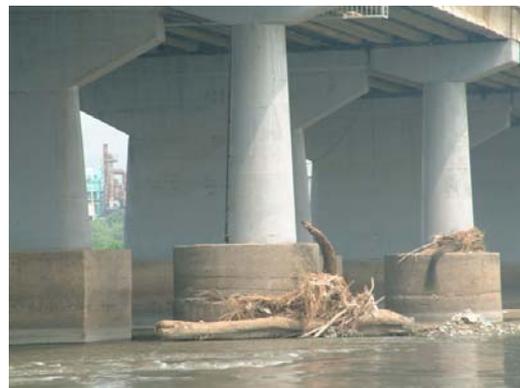
Figure 4 Debris trapped in front of the bridge piers

The top signal presents the water flow impact on the sensor, and the second signal shows the scouring processes after the sensor emerges. Based on the data recorded in the second time-series data of the Figure 3, it indicates that there is about one meter scour-depth created in this flood event. After the Aery flood, as shown in Figure 4 debris is trapped

in front of the bridge piers. It has been proven that the FBG monitoring system can function well through the severe flood.
