# Case Study – Bridges

## Chiapas Bridge

Chiapas, México, 2008

# Chiapas Bridge – Structural Monitoring System Overview

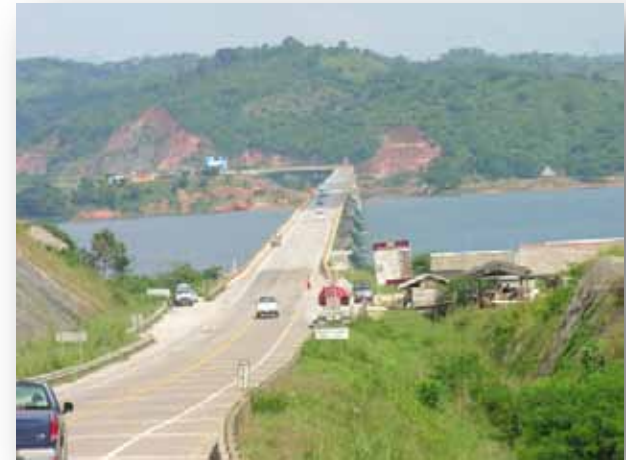
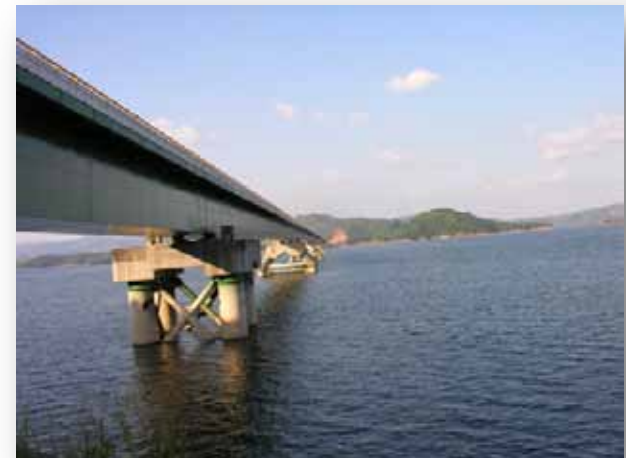
<b>Aim</b>	To monitor the integrity and behavior of the bridge structure, and effects due to high traffic and heavy truck loads that could cause possible damage & fatigue.
<b>Location</b>	Chiapas, Mexico
<b>System Integrator</b>	Chandler Monitoring Systems, Inc. <a href="http://www.chandlermonitoring.net">http://www.chandlermonitoring.net</a>
<b>Customer</b>	Instituto de Ingeniería, National Univ. of Mexico (UNAM)
<b>Date</b>	November 2-16, 2008
<b>Instrumentation</b>	(1) Micron Optics sm130-500 Optical Sensing Interrogator (1) Micron Optics sp130-500 Optical Sensing Processor Module (1) Micron Optics sm041-416 Optical Channel Switch Extension
<b>Sensors</b>	(64) Micron Optics os3100 Spot-Weld Strain Gage (18) Micron Optics os4100 Temperature Compensation Sensors
<b>Project Scope</b>	<ul style="list-style-type: none"><li>• Long-term monitoring of strain and temperature at 16 different sections along bridge span.</li><li>• System powered on-site via solar panels.</li><li>• On-site and remote data retrieval.</li><li>• Sensors monitor the strains, deflection and possible sloping of the steel girder bridge box. Data also helps determine strain variations, vibrations and expansion effects as a function of time of day, seasons and traffic.</li></ul>

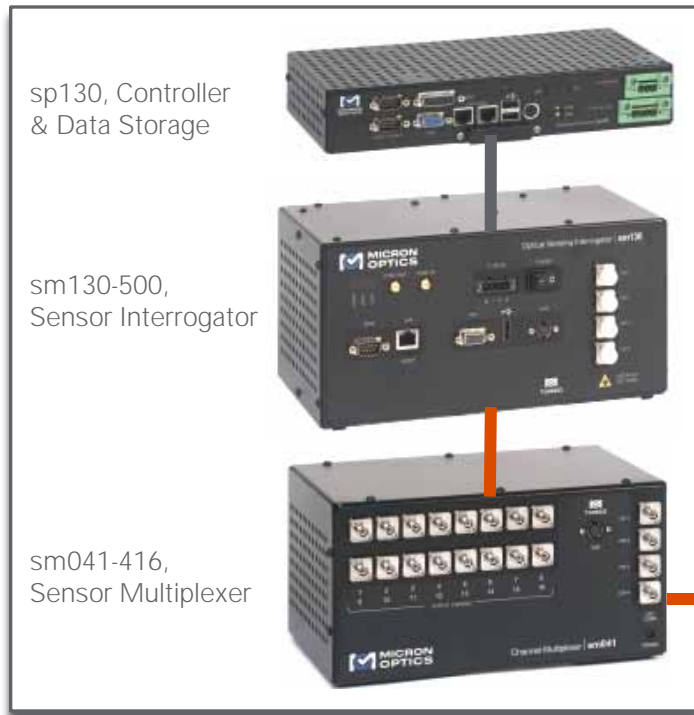
Ch 1 (Bridge Section 1)

(...) Ch 15 (Bridge Section 15)

Ch 16 ( Bridge Section 16)

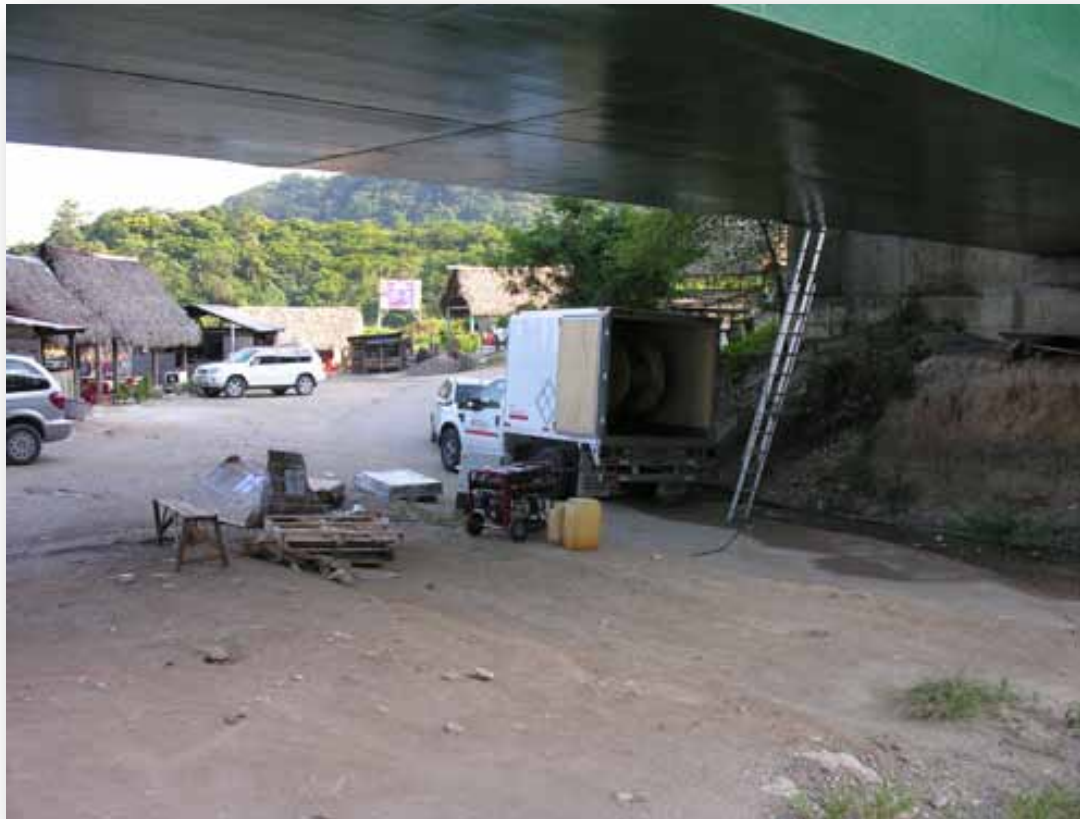
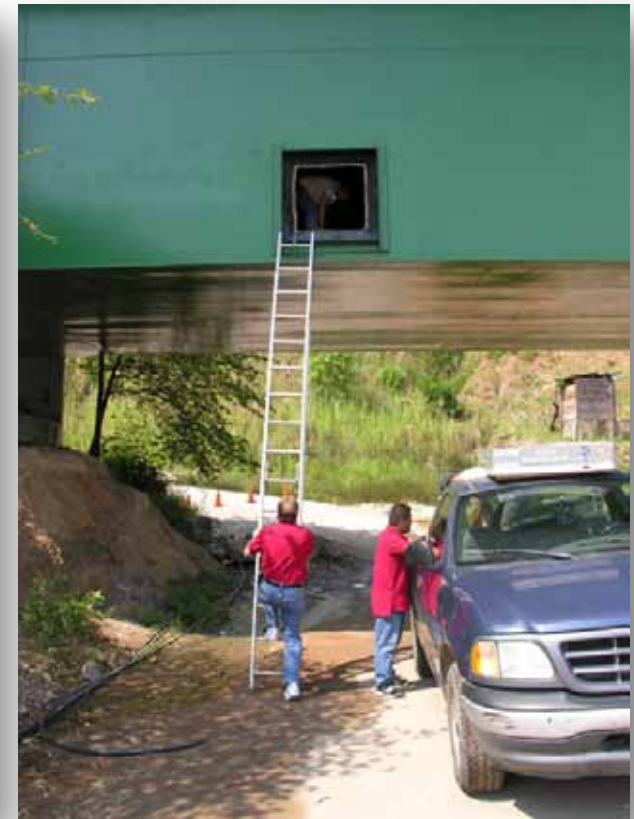
- Installation crew—Chandler Monitoring Inc.—arrives on site.
- All hardware and sensors were previously shipped to Mexico City and then trucked to the site.
- Access to the inside of the bridge is via an external access ladder.

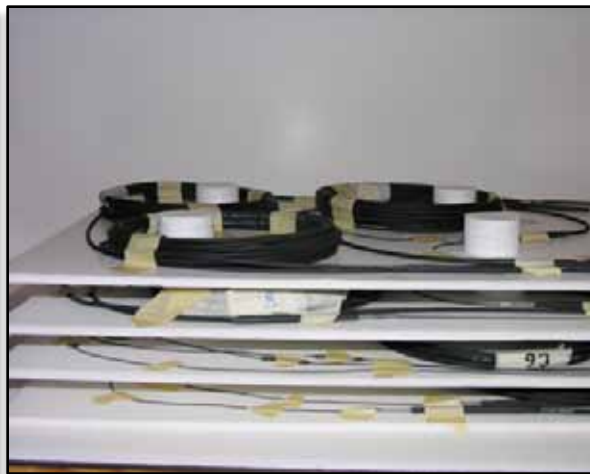
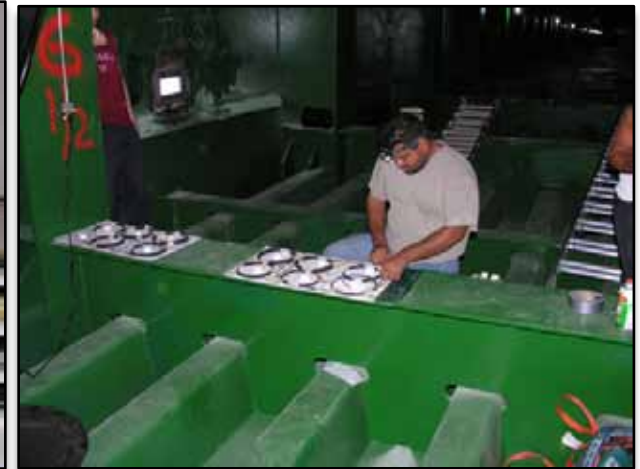
## FBG sensor arrays preparation

- Pre-assembled to length for each bridge segment
- Each bridge segment array tested before packaging
- Custom packaged before shipping to the site

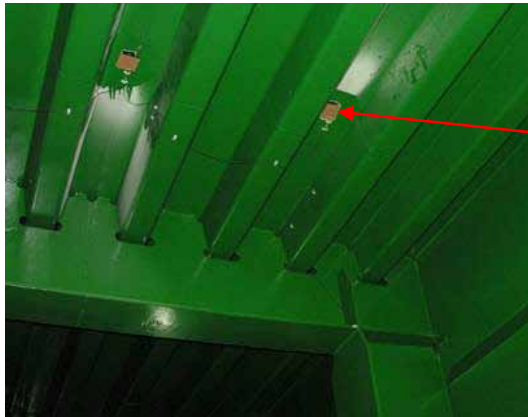
Schematic of sensor cable layout for each bridge segment tapped from main feed.

os3100 on truss ceiling..

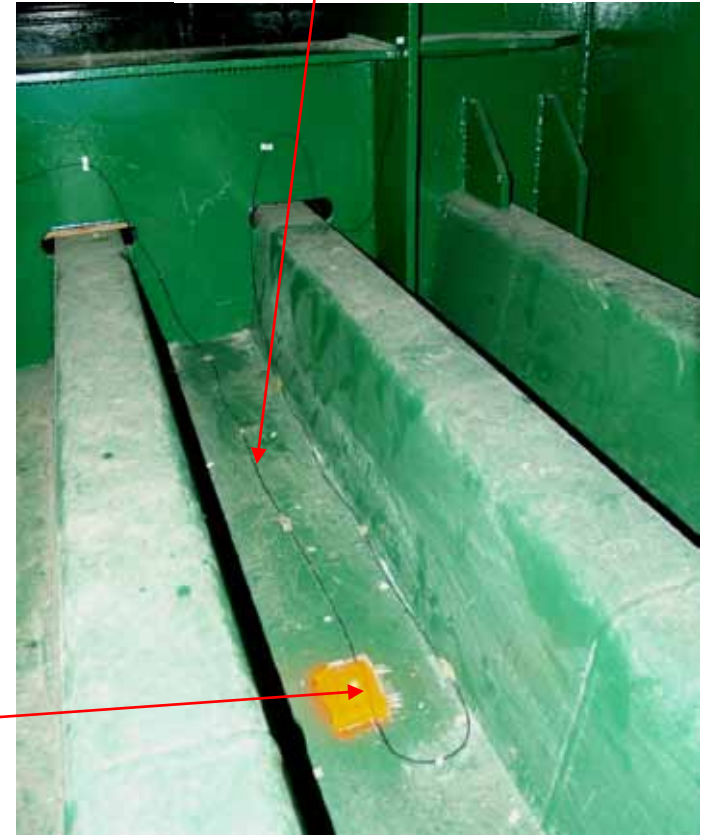
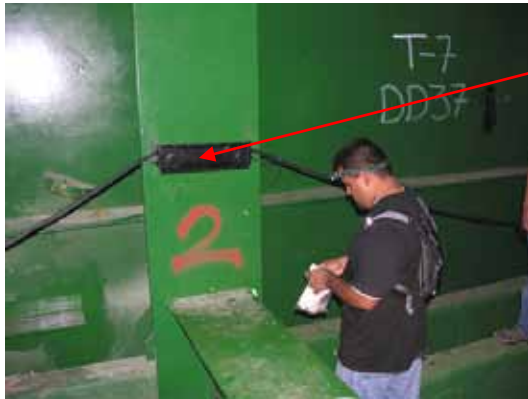
Crush resistant fiber cable.

Splice tray for segment 2.

os3100 with protective cover patch (Aquaseal)

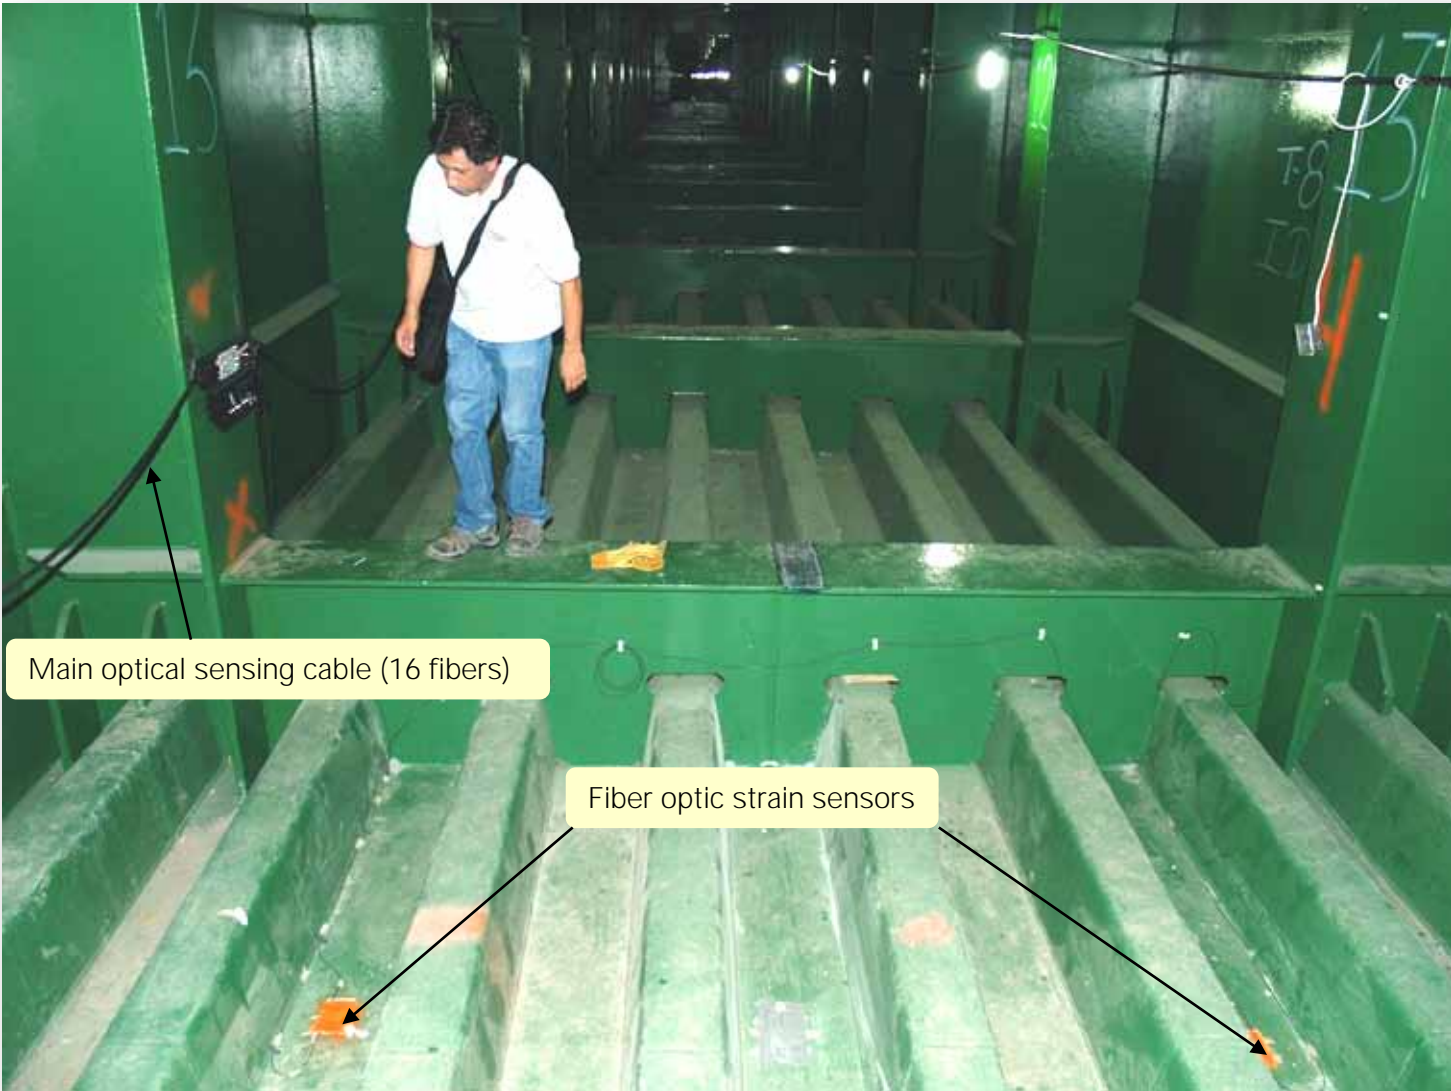
Main optical sensing cable (16 fibers)

Fiber optic strain sensors

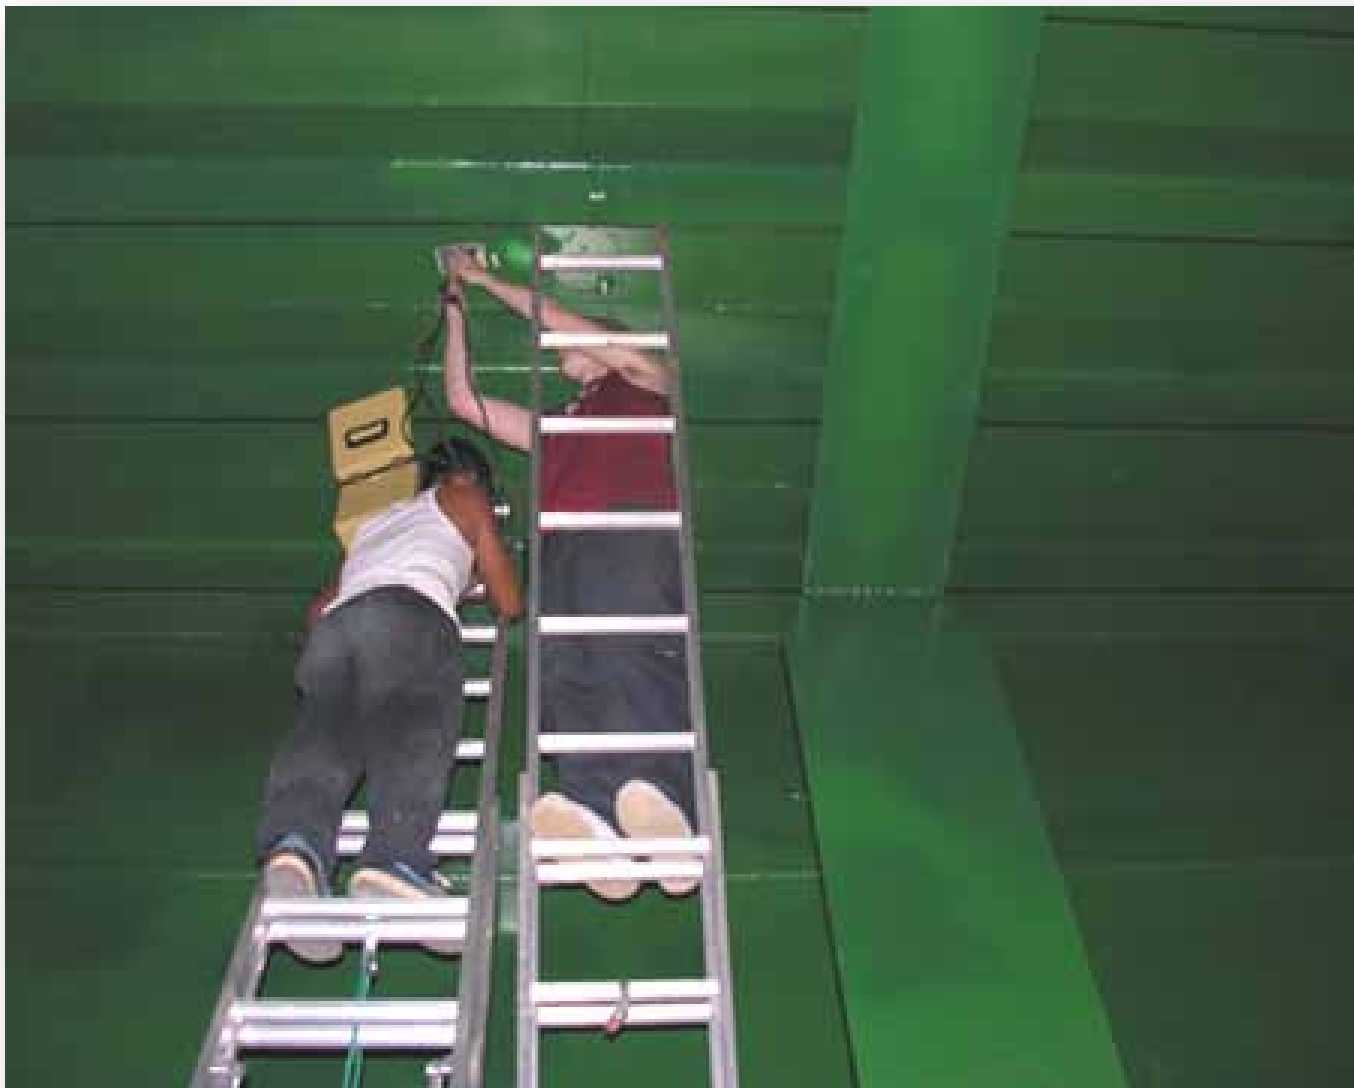
os3100 strain sensors being installed on the ceiling of the bridge truss.

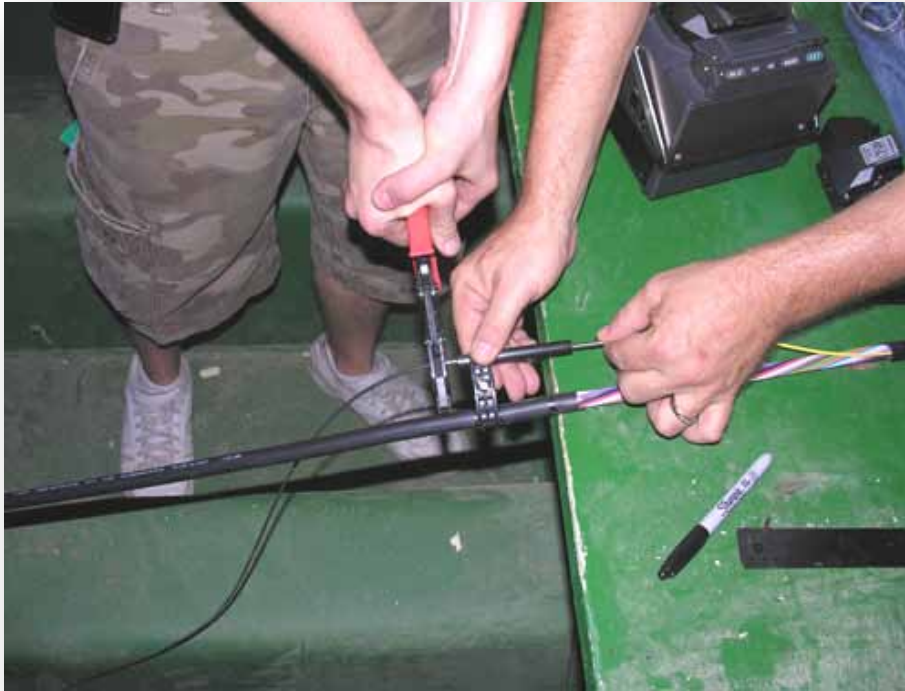
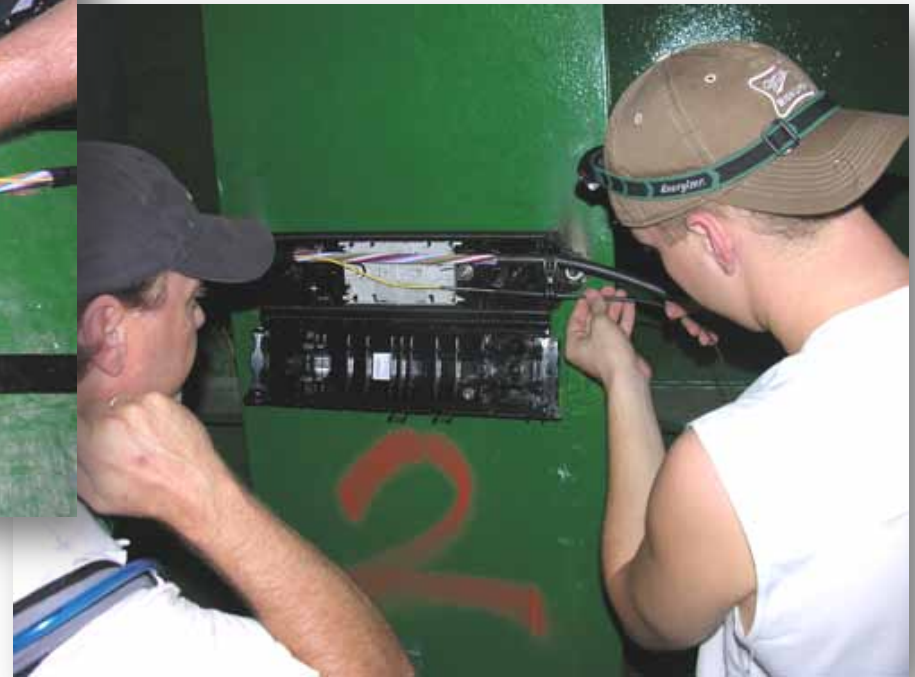
Tapping into the main 1.1km cable feed at each of the 16 bridge segment locations.

Main cable feed tapping point and industrial grade splice tray.
