# Case Study - Buildings

Structural Health Monitoring of Critical Public Buildings in Municipality of Hellinikon

Hellinikon, Athens, Greece

2008

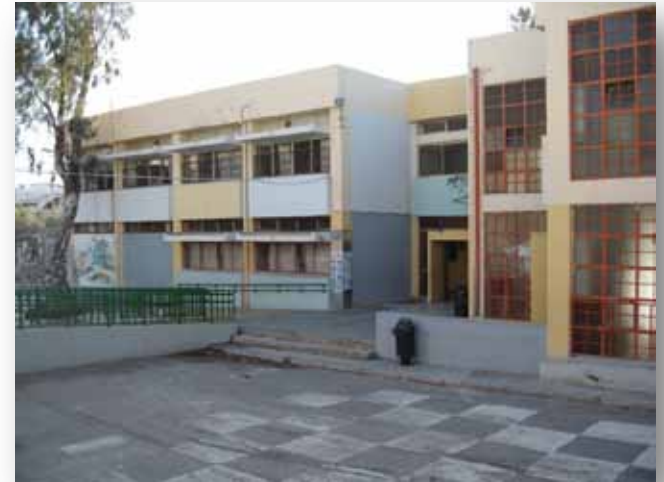
- The key parameters measured were:
  - § Strain
  - § Temperature
  - § 3-axis acceleration
- The sensors used for this project were:
  - § 250 long gage, 100mm, optical strain sensors pre-strained,  $\pm 3500\mu\epsilon$
  - § 50 optical temperature sensors
  - § 15 optical accelerometers

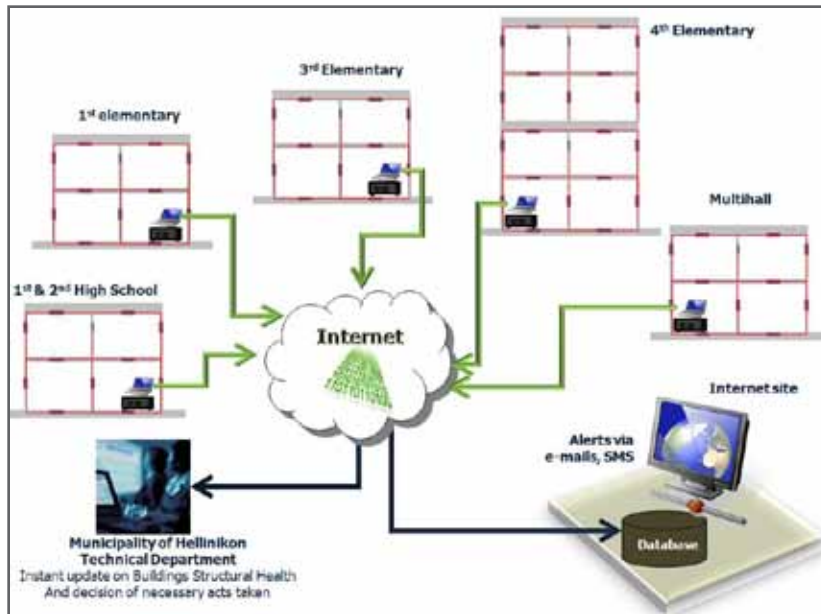
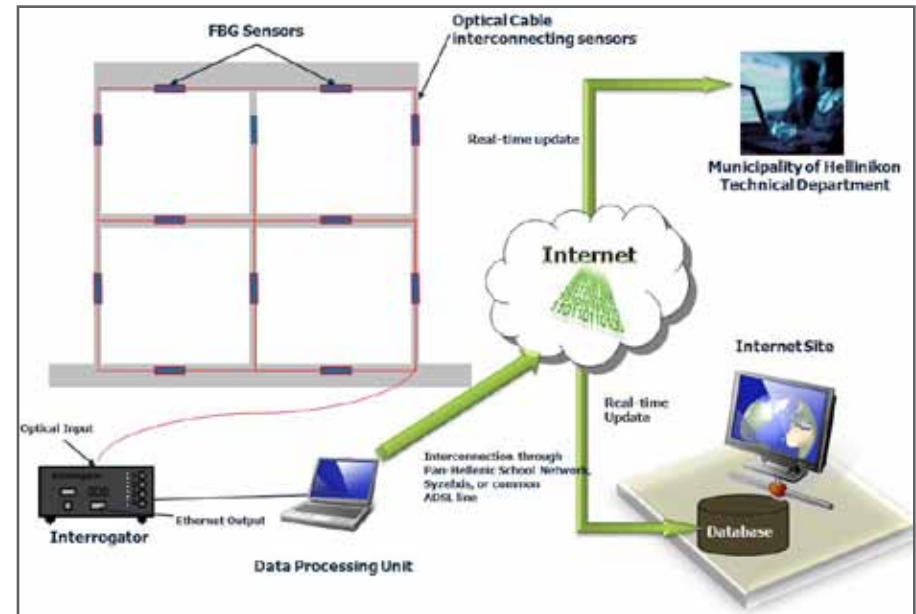
- Data is collected from the fiber optic sensors and dispatched real time to the Municipality Technical Department. In case of an emergency alerts (e-mails and SMS) are sent to key pre-determined destinations. Parents and citizens have access via project's web site, to information regarding the state of the buildings.

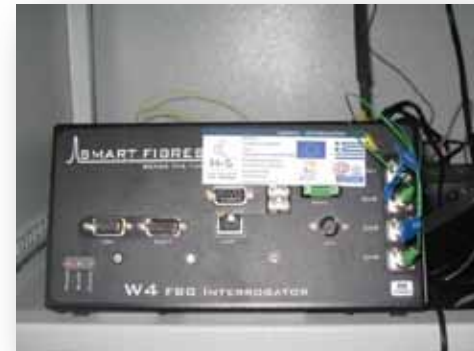
W4 (sm125) FBG Interrogator inside

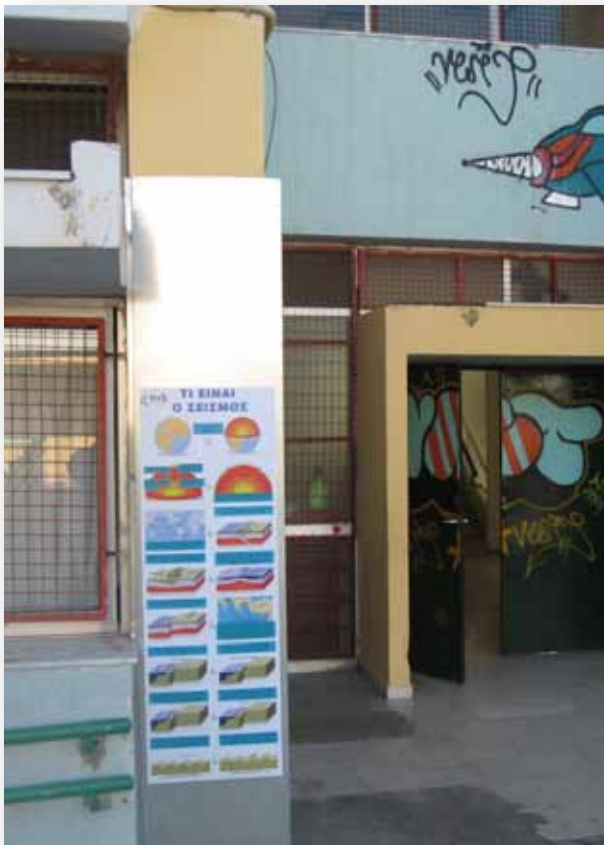
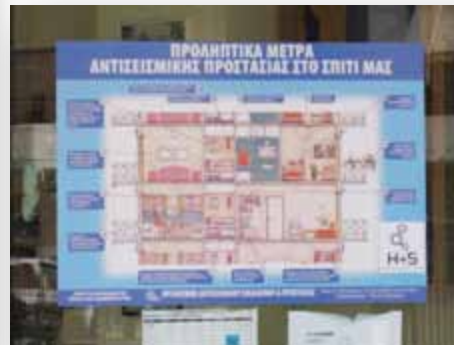
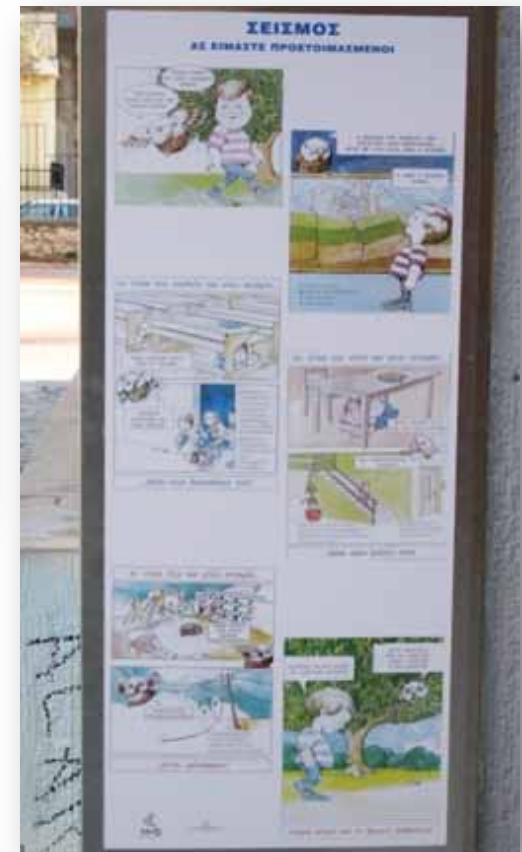
- Iron-plates cover the pillars where the sensors are placed. Stickers on each iron-plate have useful information for the children (i.e. what is an earthquake, preventive actions at the homes, what to do during an earthquake).

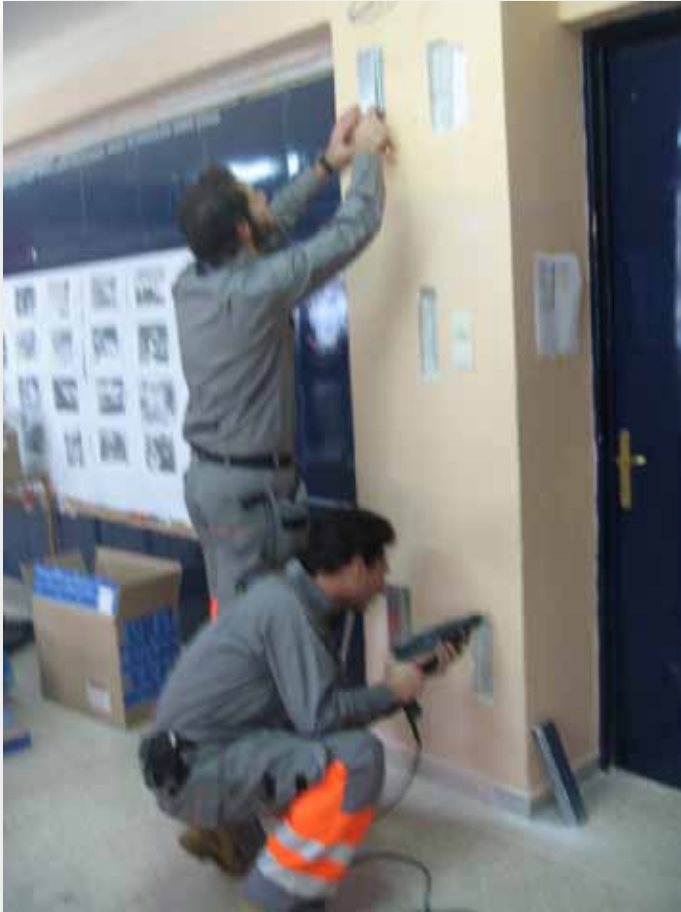
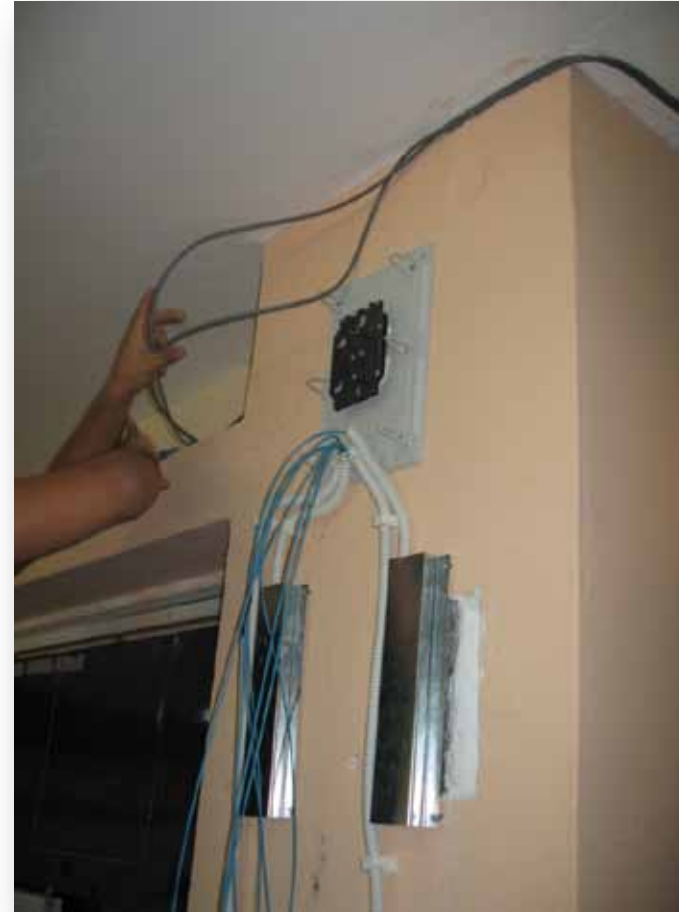
- Easy installation, no need for extra security measures, although it would be better to install sensors in non operating buildings.

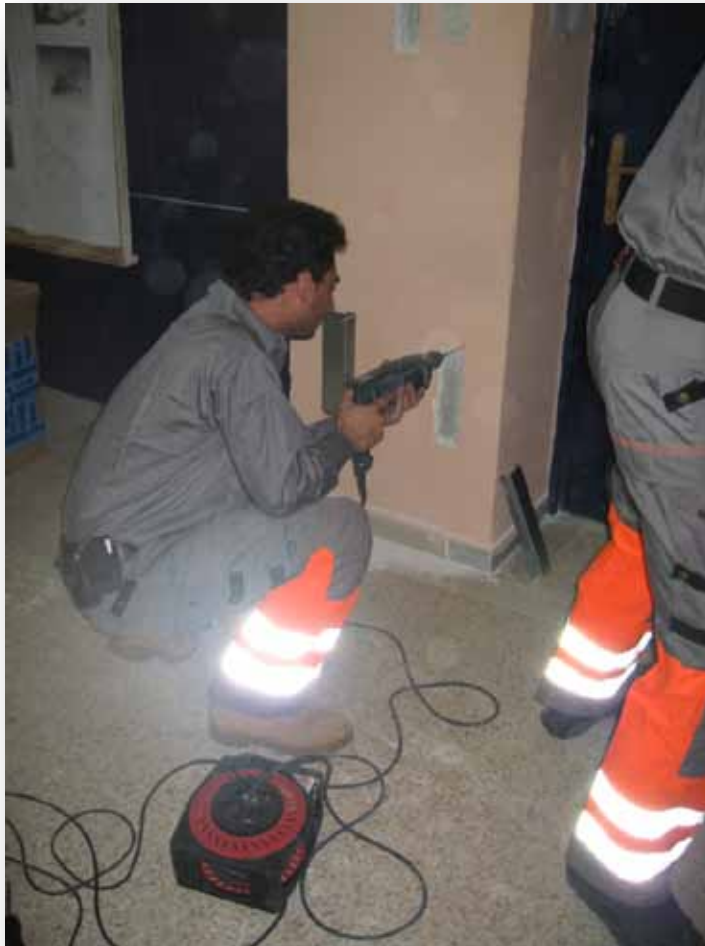
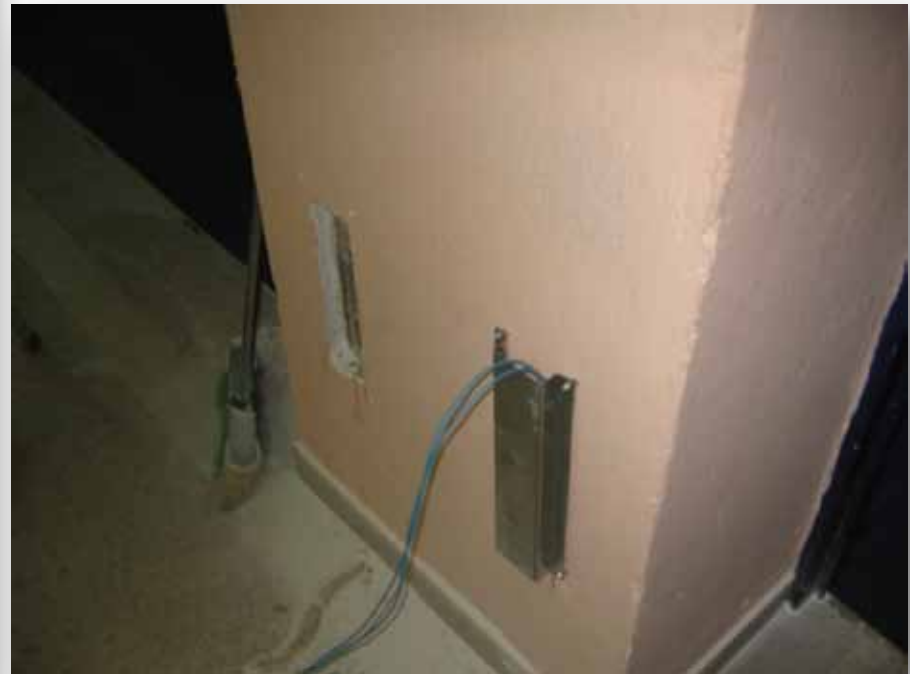
- Installation continued..

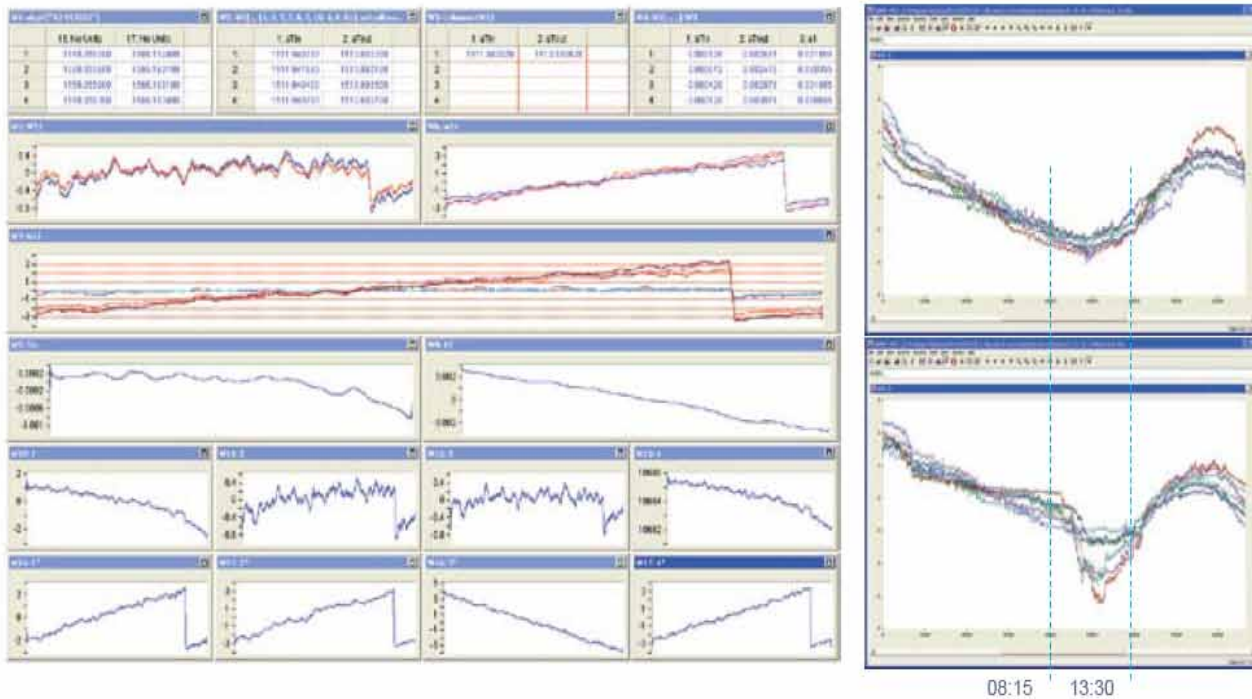
## Field Results

← A pillar's behavior during a day without kids (Saturday).

← A pillar's behavior during a working day (Monday). The change of the curvature takes place from 08.15 to 13.30, the working hours, and indicates the children's extra load.
