Hampden Suspension Bridge

- Long term structural health monitoring
Kangaroo Valley, NSW, Australia, 2005

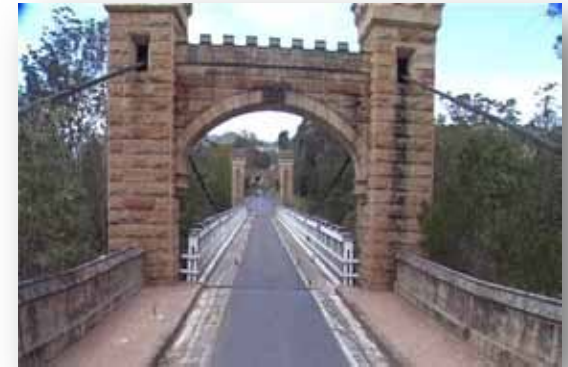
- § To this end, the RTA commissioned Monitor Optics Systems to develop and implement a long term, automated, structural health monitoring system for the bridge.
- § Monitor Optics Systems developed and installed a fiber optics based strain sensing system on the bridge. Surface mounted sensors measure strain in critical structural elements. The multiplexed sensors are routed to a control room at the bridge abutment.

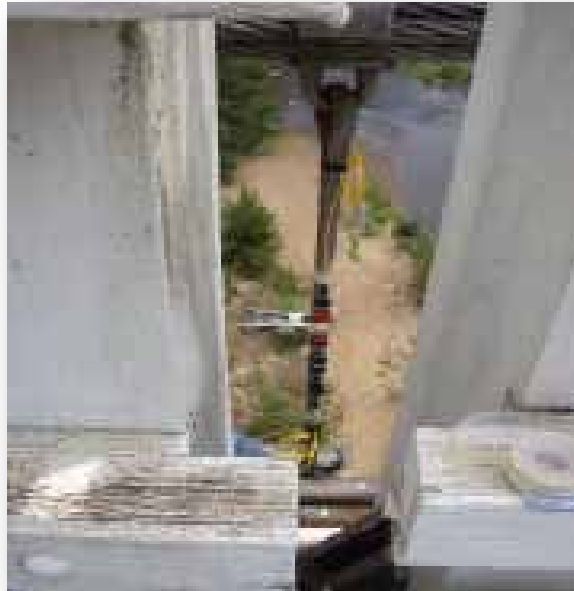
- § The Micron Optics si425-500 continuously interrogates the sensors. The acquired data is processed and transmitted automatically via GPRS.
- § The MOS Monitoring System provides a real-time measure of the structural condition of the bridge.

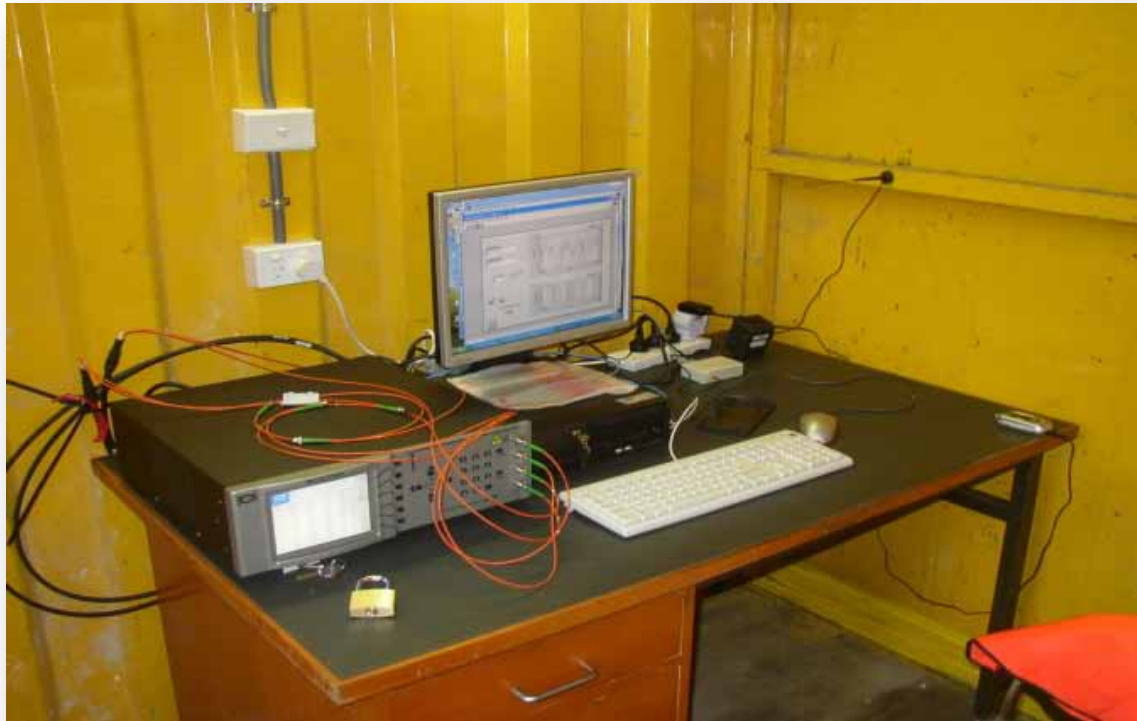
§ A detailed traffic loading profile is compiled from the accumulated data, permitting the development and policing of an appropriate traffic control regimen.

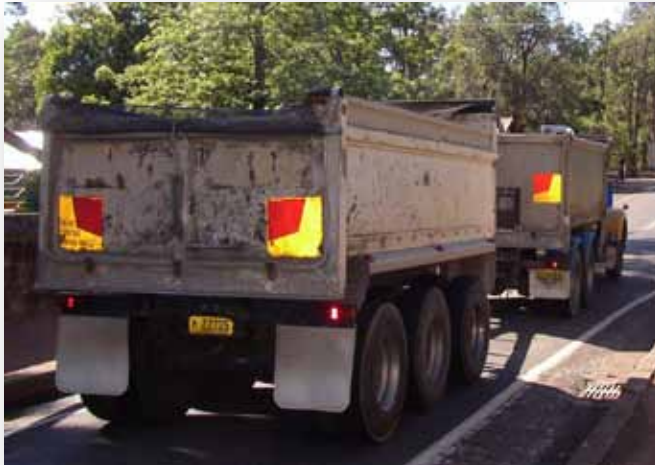
MONITOR OPTICS		Hampden Bridge Monitoring System				
15/12/2004						
Event	no.	34				
Class	3					
5:15:20						
Acquisition frequency:	25 Hz					
Maximum strains:						
TR02AS	TR02BS	SR62S	SR78S	TR39AS	TR39BS
