ABOUT WILTON ROAD

Roadway Monitoring

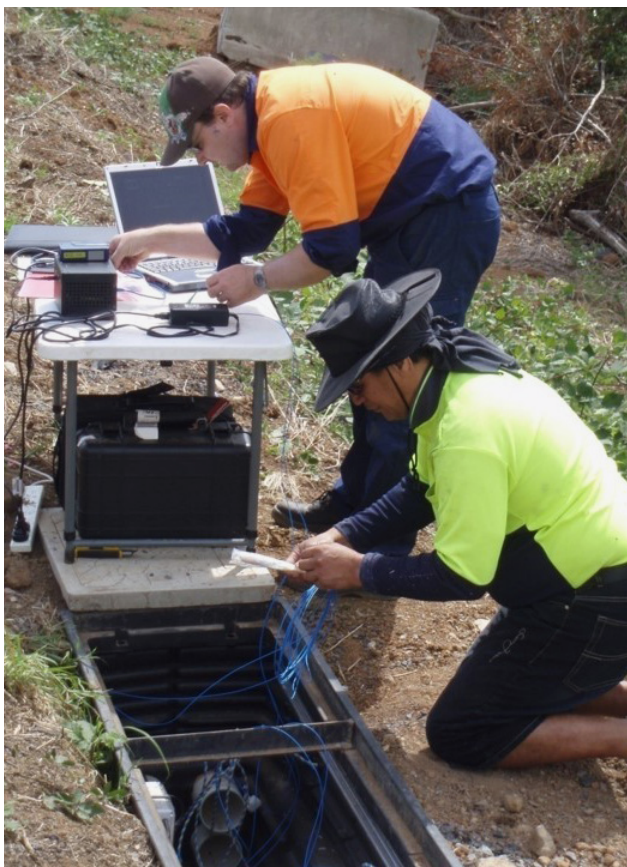
A Luna sm125 was used in the field for its proven reliability and accuracy

(1) Luna sm125 Optical Sensing Interrogator was used in conjunction with (5) FBG Distributed Temperature Sensor Cables and (10) FBG Distributed Strain Sensing Cables

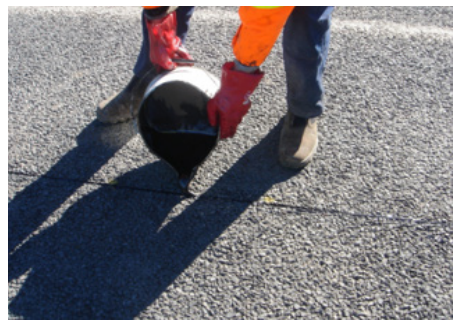
Epoxy resin poured around the 1 mm diameter cables in one application

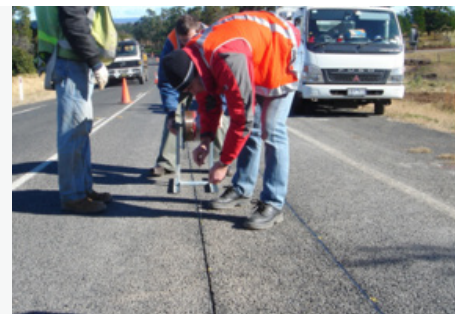
Sensors embedded into wet pavement and manually placed into groove via spool reels

During installation, the optical fiber sensors encased in GFRC were placed in the asphalt layer approximately 5 cm below the surface down a 90-meter-long section of pavement on Wilton Road. Temperatures are also measured at strain sensing locations for determining thermally induced strains.
