Hsin-Han Bridge

- Characterizing aged bridge response by loading test
Tao-Yuan County, Taiwan, January 2005

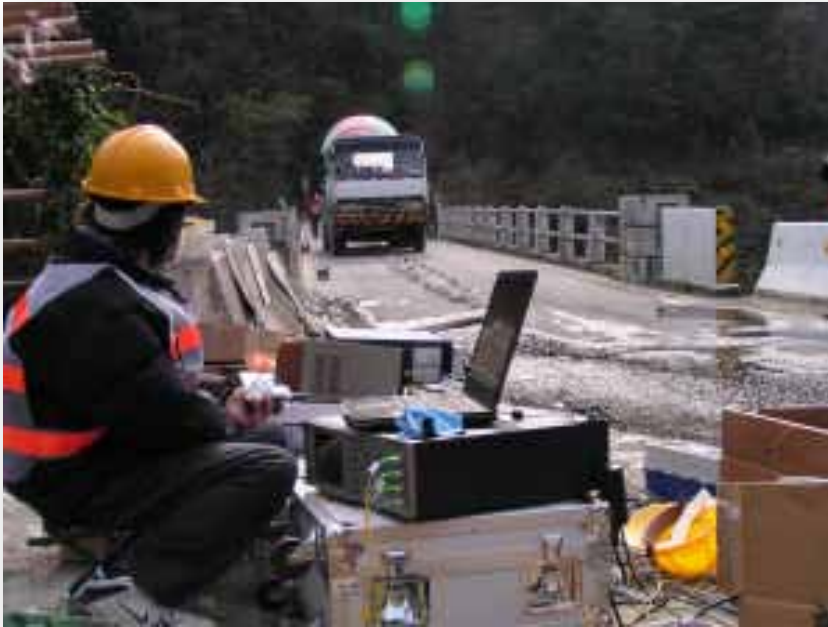
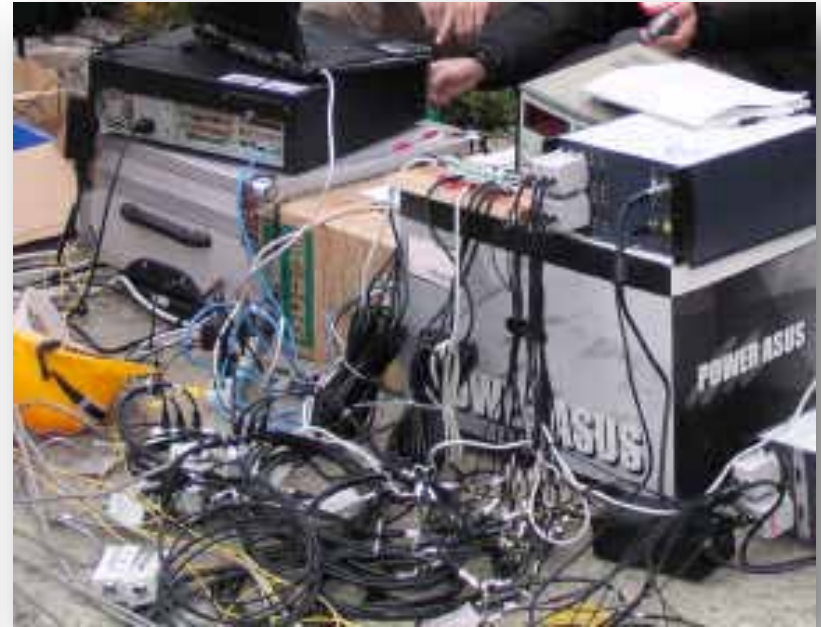
Hsin-Han Bridge – Data Results

In static loading test, a heavily loaded truck was parked at specified locations on the bridge for data recording. While in dynamic load testing, the same truck was driven across the bridge at 30km/hr speed and the FBG interrogator si425-500 recorded all the data at full speed of 250Hz.

- § Results of this test are still being processed and calculated to yield a final report to the township authority.
- § Qualitative results had already shown feasibility of this method in determining bridge safety.
- § Further improvements and modifications will be made on stage fixtures for the FBG Bending Gauge for several project of CBER in the near future.
- § After this case study, team members of CBER praise the advantage of optical fiber sensor, especially for its immunity to EMI and multiplexibility that greatly reduce the loathsome line processing.
- § Now, the CBER is keeping its direction to make use of this technology and POFC optical sensing products as their main tool for bridge health diagnosis.
